Surface Photovoltage and Contact Potential Difference Imaging of Defects Introduced by Plasma Processing of IC Devices.

K.Nauka, J.Theil, C.Chi, W.M.Greene, and J.L.Shohet^{1),a)}

Hewlett-Packard Company, Palo Alto, CA 94304.

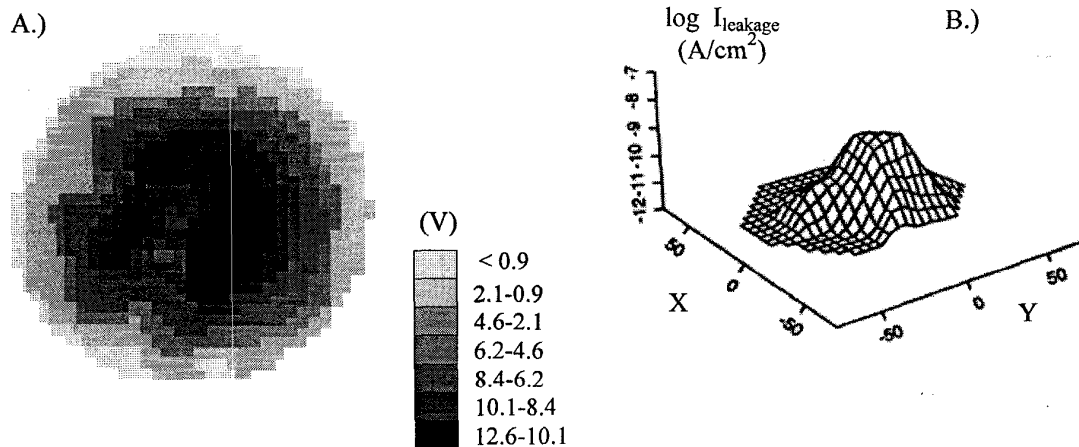
CPD and SPV mapping showed a strong correlation between the plasma processing conditions and generated defects. For a majority of investigated cases dielectric's surface charging responsible for an antennae damage was the primary source of the plasma induced defects. Fig.1.A presents an example of plasma induced charge distribution on the oxide's surface, and Fig. 1.B. shows the corresponding 3-D projection of capacitor leakage. An excellent correlation between both maps demonstrates that, in the presented case, dielectric charging and

Figure 1. A.) Oxide surface charge maps (CPD units); B.) corresponding maps of the MOS capacitor leakage (80 nm gate oxide). Wafer was subjected to the pre-metal Ar plasma sputtering clean.

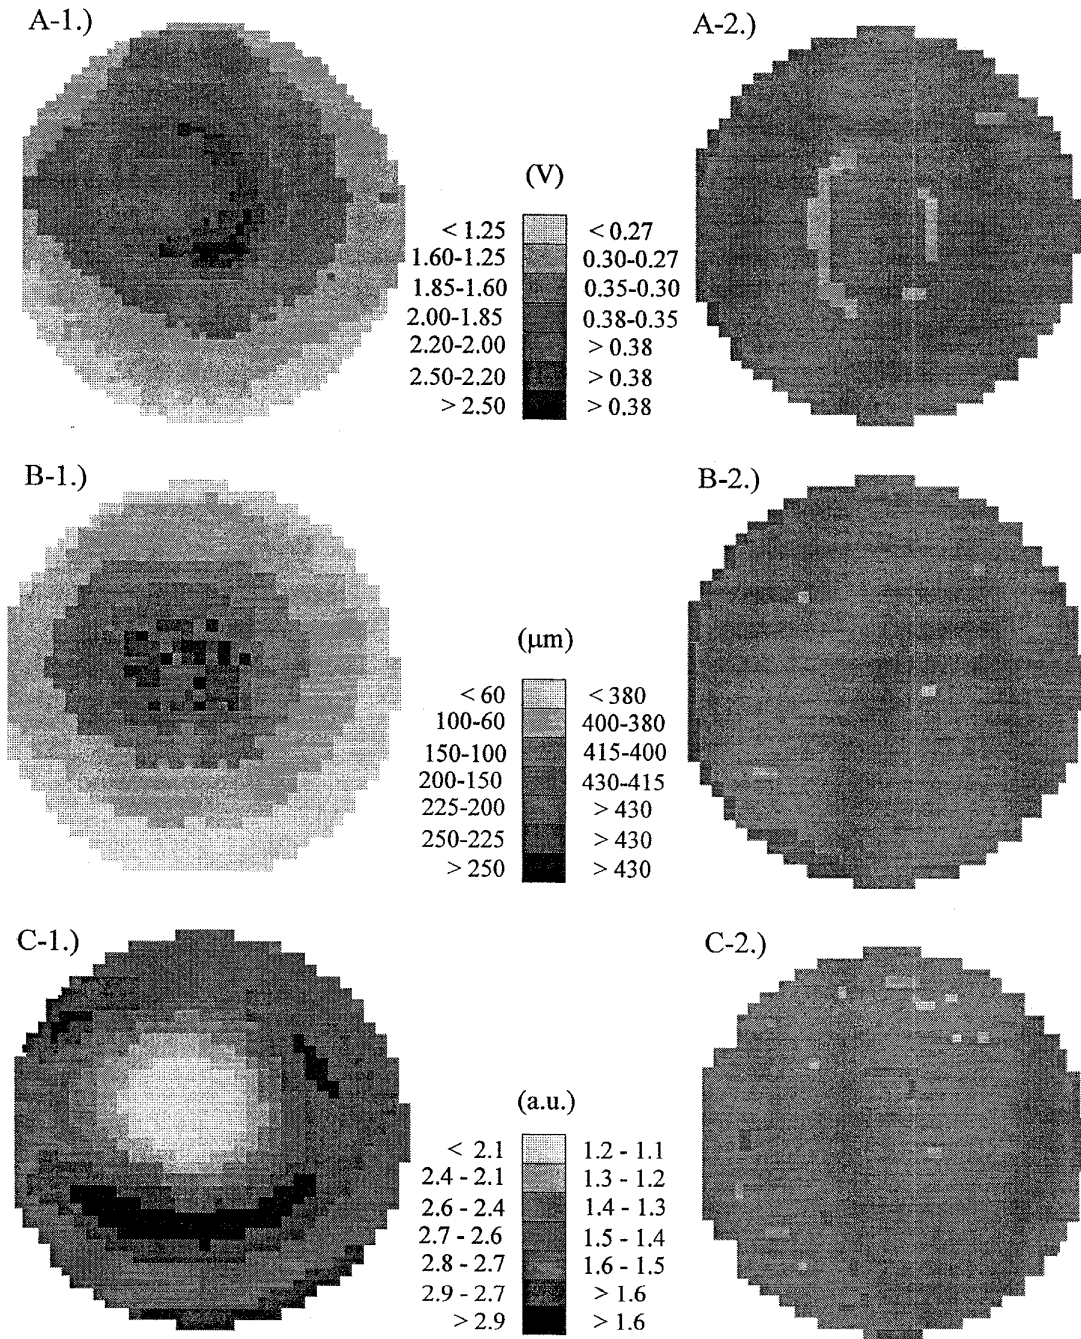
corresponding antennae damage was responsible for device degradation. However, in many cases both aforementioned damage mechanisms were present. Fig. 2 compares the CPD measured distribution of dielectric's surface charges causing antennae damage, and the SPV measured degradation of the bulk Si and bulk oxide properties due to radiation damage. In this case, device failure is likely to be due to both damage

processes. It was also observed that even minor changes in the plasma generation conditions, such as pressure, flow rate, and configuration of magnetic and electric fields could had a major impact on defect patterns observed with CPD and SPV, and the corresponding device degradation.

Figure 2. Si wafer after Ar plasma clean: A-1.) CPD map of the oxide surface charges, B-1.) SPV map of the minority carrier diffusion length, C-1.) SPV map of the net bulk oxide charges; A-2.), B-2.), and C-2.) are respective maps obtained for the reference wafers (wafers before plasma treatment).
