# A Complete Approach to the In-line Monitoring of Materials Defects Introduced in Dielectric and Si by Plasma Processing.

K. Nauka, J. Theil, J. Lagowski<sup>1)</sup>, L. Jastrzebski<sup>1)</sup>, S. Sawtchouk<sup>1)</sup>

*Hewlett-Packard Company, Palo Alto, CA 94304; <sup>1)</sup> Semiconductor Diagnostics, Inc., Tampa, FL 33612*

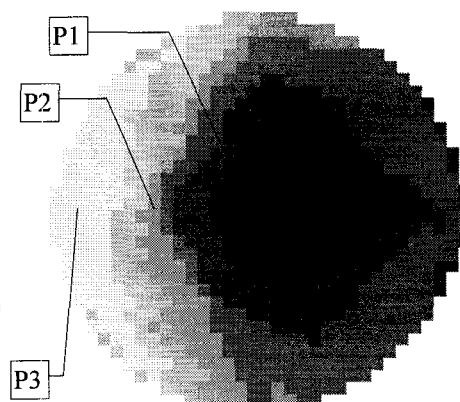
Figure 3. CPD map of the oxide surface charge.

Figures 3, 4, 5, 6 demonstrate defect mapping results obtained for the wafer processed under following conditions: plasma power = 100 W, magnetic field strength = 30 G, fast rotation. Figure 4 shows CPD measured bulk oxide defect related leakage under negative and positive surface charge induced bias stress conditions. Similarity of maps in Figure 4 indicates that bulk oxide defects induced by plasma are mostly present in the wafer's center. Corresponding reference wafer maps (wafers measured before plasma processing) were uniform, and they had the following mean values of the measured signal: (1) oxide surface charge (CPD (V)) = 0.24, (2) Si - oxide interface charges (SPV (high intensity illumination) (a.u.)) = 34, and (3) minority carrier diffusion length in Si (SPV (low intensity illumination) ( $\mu\text{m}$ )) = 340.

Change of the plasma parameters did not have significant impact on distribution of defects shown in Figures 3 - 6. It was surprising to find that elimination of wafer's rotation had no impact on defect distribution. However, change in plasma processing condition affected defect mean concentration and distribution uniformity expressed in terms of standard deviation of the measured signal. Figures 7, 8, 9, and 10 demonstrate impact of the plasma conditions on

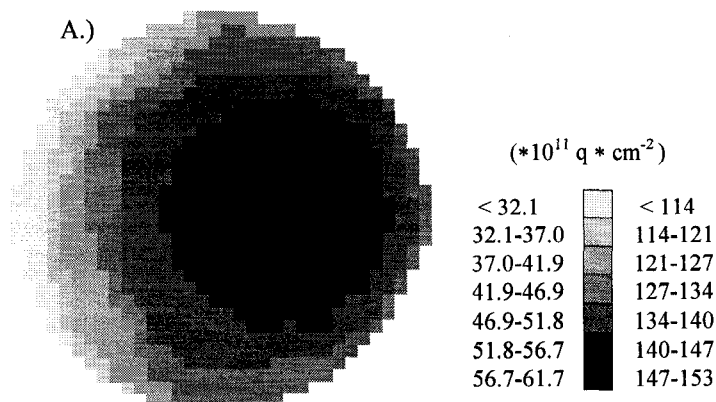
Figure 4. SPV map of charges at and near Si-oxide interface.

In order to further elucidate the nature of bulk oxide defects C-V measurements were conducted at locations P1, P2, and P3 shown in Figure 4. Summary of the C-V data is shown in Figure 11, 12, and 13. C-V results are in qualitative agreement with the mapping data in Figures 4 and 5. They reflect non-uniform distribution of oxide defects; ratios of  $Q_f$  and  $Q_{it}$  found in the center (P1) and near the edge (P2) correspond to CPD and SPV signal ratios observed in the corresponding defect maps. In addition, C-V confirmed changes in defect population caused by changing plasma processing conditions. It was also seen that investigated plasma process had no impact on the mobile oxide charges.

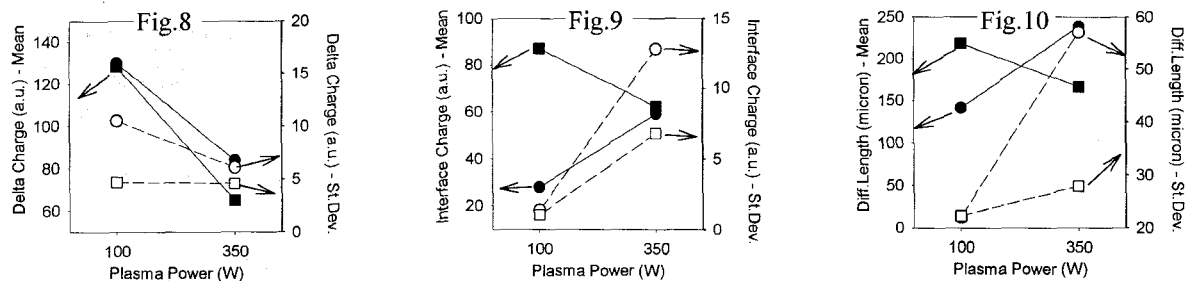
Figure 7. Effect of plasma conditions on CPD measured oxide surface (further explanation - see below).

defects. It appears that decrease of plasma generation power and magnetic field increased number of charges on the oxide's surface and caused formation of a larger number of defects in the oxide bulk. However, larger number of Si - oxide interfacial defects and bulk Si recombination centers were observed when plasma generation power was decreased and field strength was increased. It might be that two different mechanisms are responsible for generation of these two groups of defects.

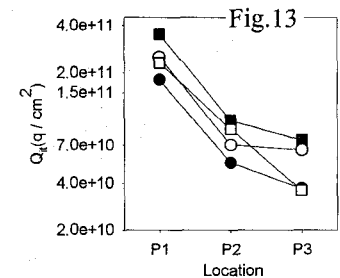
Figure 12, 13.  $Q_f$  and  $Q_t$  as a function of plasma conditions. P = plasma generation power, M = magnetic field strength. Square/black - P = 100 W, M = 30 G, circle/black - P = 100 W, M = 85 G, square/white - P = 350 W, M = 30 G, circle/white - P = 350 W, M = 85 G.

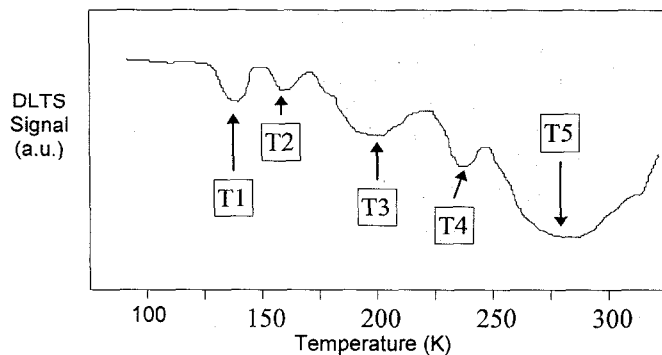
Figure 14:

trap	activation energy (eV)	origin
T1	0.25	Ti
T2	0.28	Mo
T3	0.35	point defects
T4	0.45	Fe
T5	0.5	point defects

SPV measurement demonstrated that plasma processing significantly reduced minority carrier diffusion length. DLTS analysis was conducted to investigate Si bulk defects that might act as minority carrier recombination centers. At least five deep states were observed (Figure 14). Three of them are related to metallic impurities (Fe, Cr, Mo), the other two are probably caused by native point defect complexes that were introduced by highly energetic particles, ions, and photons originating from the plasma. Measurement of defect concentrations and capture cross section indicate that recombination centers related to native point defects are primarily responsible for lifetime degradation.
